JAMESON DAM

NDI ID NO. MD 38

PHASE I INSPECTION REPORT

11 MAY 1979

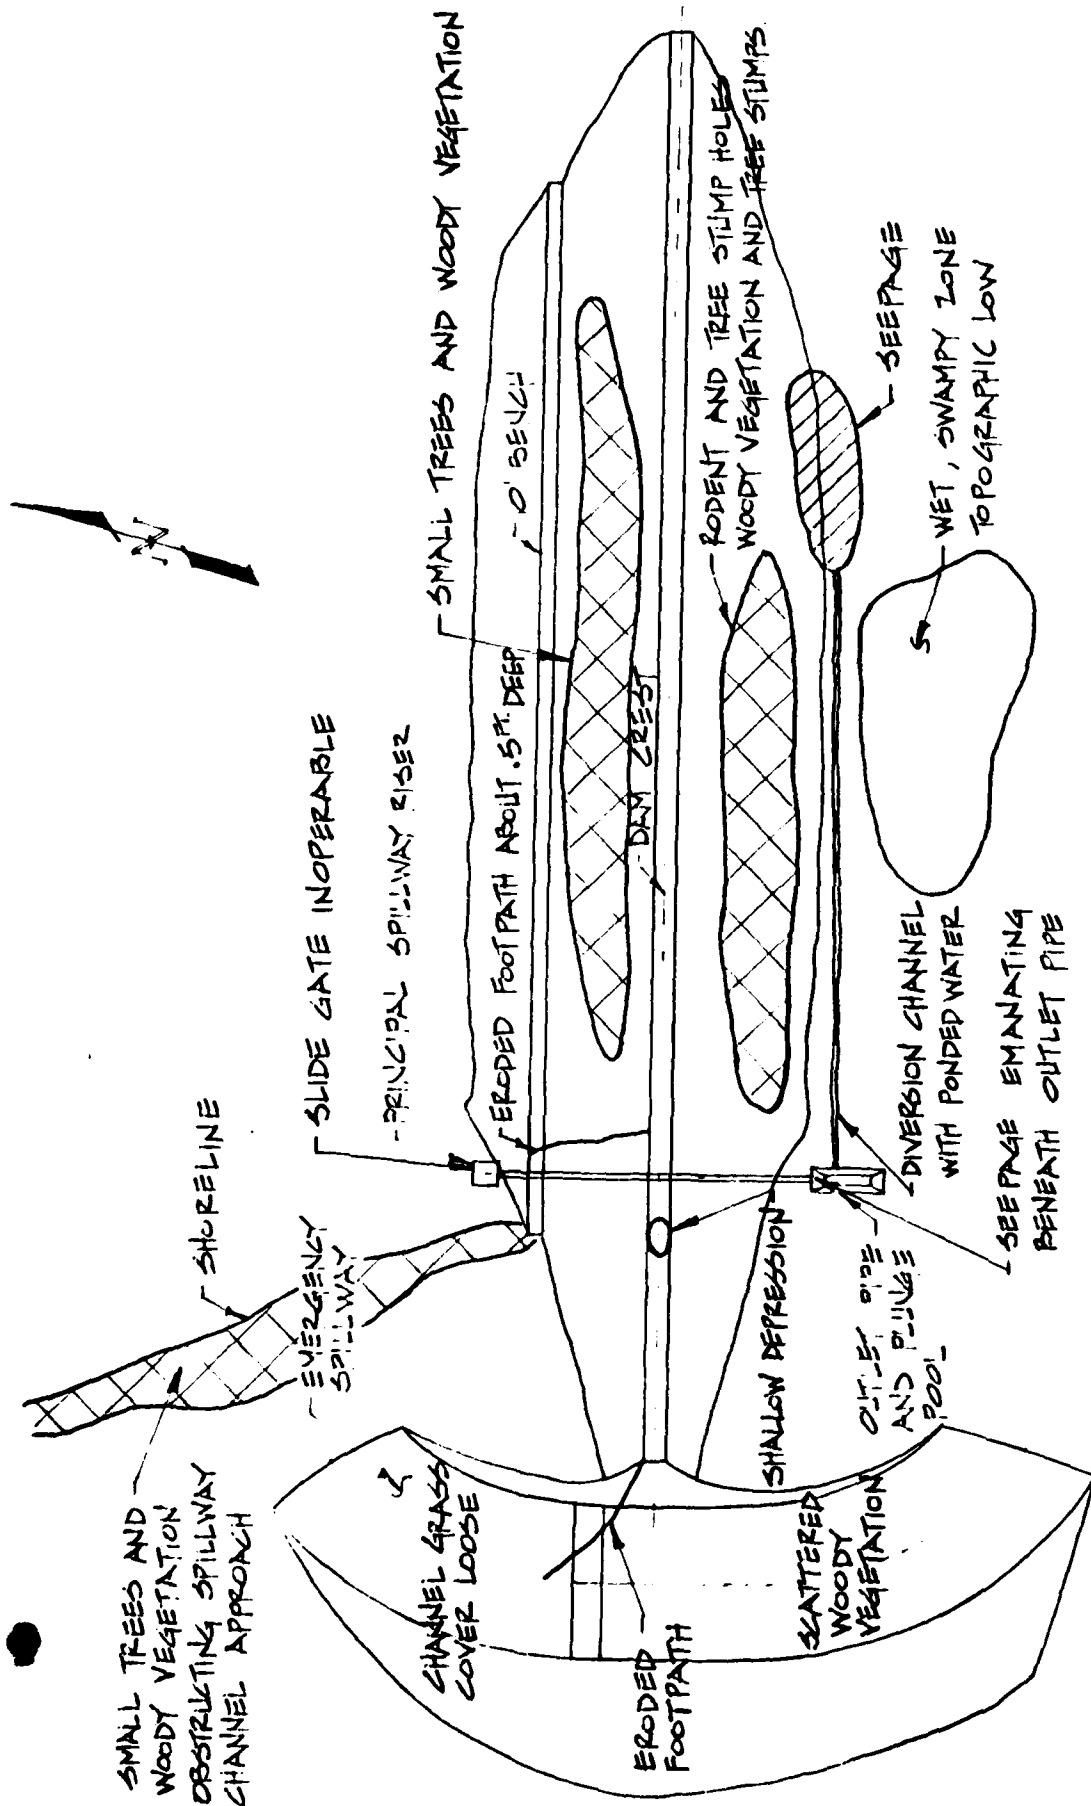
FIELD SKETCH JAMESON DAM

3. Seepage. As shown on the field sketch, a moderate volume of seepage was observed emanating from the toe of the downstream slope. This seepage was observed clear, but had apparently transported a fine sand material, as evidenced by small sand deposits. The location of the seepage sources approximately correspond to the "as-built" location of the blanket drain. Therefore, it is assumed the seepage originates from this outlet drain. It is further suspected the fine sand deposit is a transported product of the filter drain material.
